**RAILWAY INVESTIGATION REPORT**  
**R99H0010**

**DERAILMENT AND COLLISION**

**MILE 50.84, SAINT-HYACINTHE SUBDIVISION**

**30 DECEMBER 1999**

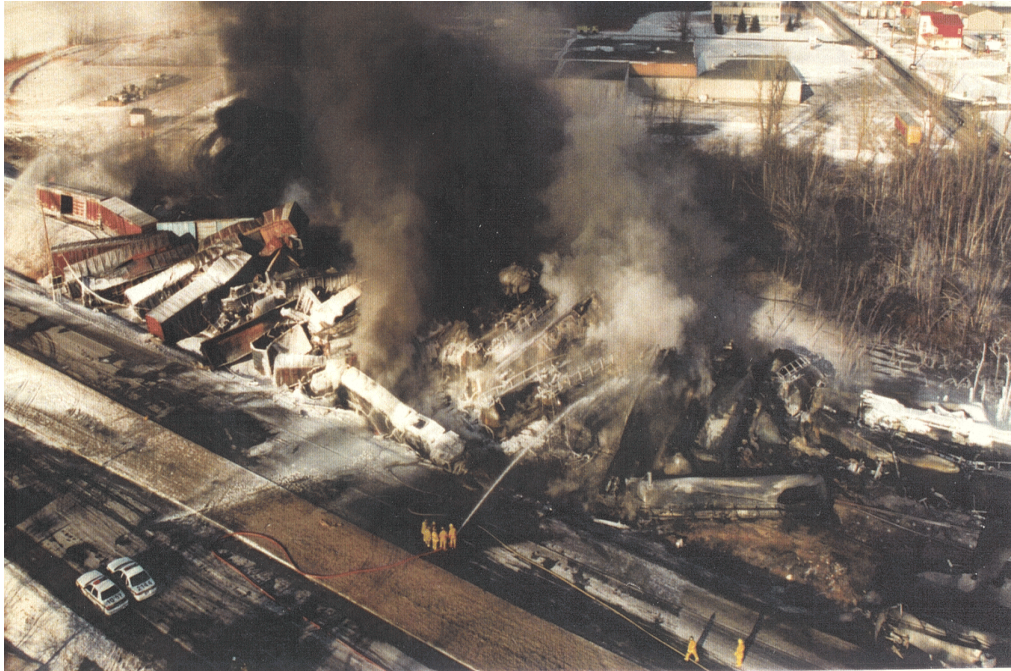
Figure 2—Overview of scattered cars

tank cars loaded with hydrocarbons from train 783 were punctured, and almost all rolling stock in the derailment area was on fire. The fire was isolated and brought under control during the night of 30 to 31 December, but continued to burn for four days.

Thirty-five tank cars from train 783 derailed (the 11th to 45th cars). Thirty of the derailed cars sustained considerable damage and were demolished at the site. The tanks of these cars were punctured and torn open, and the safety valves and isolation valves were ripped off. The other five cars sustained minor damage.

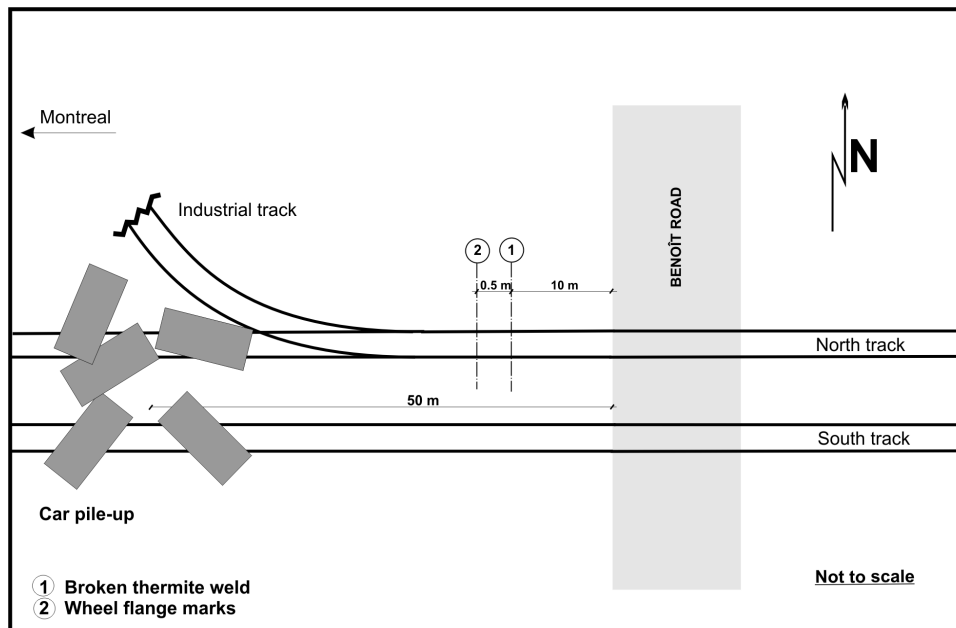
Figure 3—Location of broken weld

The south rail of the north track broke at a thermite weld located 10 m west of the end of the crossing and 1.5 m east of the switch point for the industrial turnout (see Figure 3).

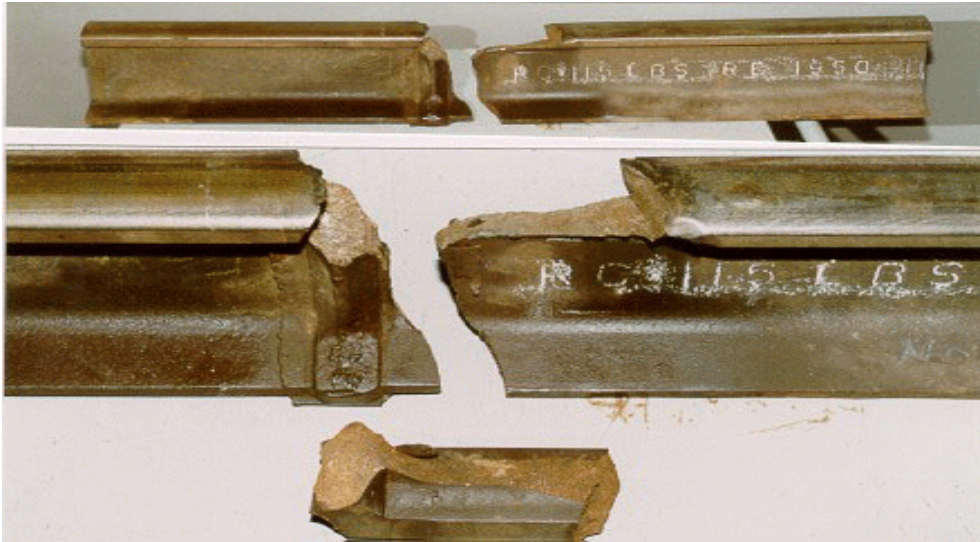
Figure 4—Rail fracture

The rail was displaced laterally and the east rail end was rolled over. The break had the form of a T; it was vertical in the base and web, separated into two horizontal branches at the junction of the web and the head of the rail, and then continued vertically again in the head (see Figure 4). A rail head section, 150 mm in length, separated from the rail and was found on the ground beside the south rail, a few feet east of the weld.

The south rail of the north track broke at a thermite weld. No wheel flange marks or scrape marks were found east of the broken weld; consequently, it may be concluded that the derailment did not occur to the east of the weld. The shape of the first scrape observed on the field side of the rail head, immediately west of the weld, indicates that the wheel flange climbed the rail at that point; this is also consistent with the wheel flange marks seen on the turnout gauge plate and the tie plate west of the weld.

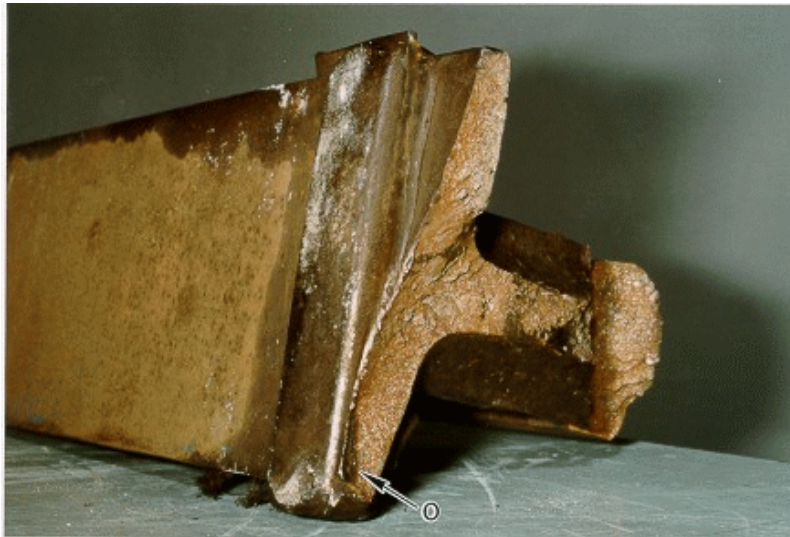
Figure 5—Location of pre-crack (O)

A semi-circular dark area containing a pre-crack was located on the field side of the weld fracture surface, on the lower corner of the rail base (see Figure 5). It was 29 mm wide and 6 mm high and was located 22 mm from the weld axis. The pre-crack was located in the heat-affected zone of the weld, near a sudden change in the cross-section. The surface of the pre-crack was highly oxidized and showed no signs of recent growth.

The two surfaces of the pre-crack were cut out of the east and west rail sections. Analysis of these pieces with a scanning electron microscope and a metallurgical microscope confirmed that the pre-crack had begun in an area of acicular ferrite, a microstructure that has less resistance to fracture and impact, and that there was no recent extension of the pre-crack.

Residual strength was analyzed using specialized fracture mechanics software. For a defect comparable in size to that found on the thermite weld (29 mm wide by 6 mm high), residual strength falls from 92 ksi to 30.13 ksi, or approximately 33 per cent of the initial yield strength.

The chevron markings observed on the fracture surfaces are consistent with a rapid overstress fracture. The direction of these markings indicates that the break originated in the pre-crack area located in the lower corner of the rail base. Once initiated, the fracture occurred quickly, with the head of the rail breaking last. The pre-crack showed no signs of recent growth. It lacked the black colouration, which is usually associated with oxidation at high temperature, indicating that it formed after the weld was made, probably as a result of residual stresses created during welding. The thickness of the oxide layer indicates that the pre-crack was at least nine months old.
